Failures in Progress

Since June, 2003, Pepper Industrial Maintenance has been observing and monitoring the imminent failure of an extremely large, high horsepower gear reducer. The customer is fully aware of the deteriorating condition of the equipment. Pepper Industrial Maintenance will continue to monitor the situation until the customer is able to remove the equipment from service for maintenance and repair.

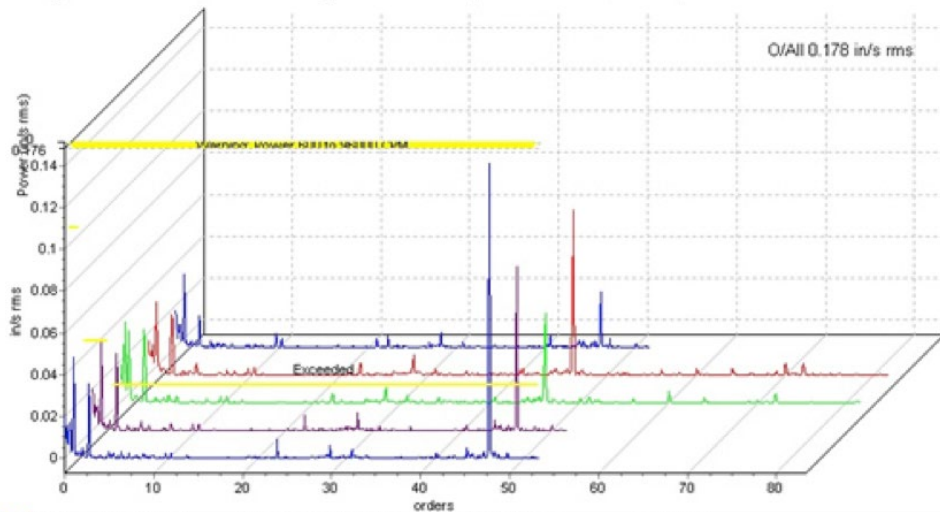
in-line drive - mtr-de - Radial

7/3/03 Read at 9:31 was no load. steady increase indicates forces no longer confined to reducer, we are now damaging motor bearings and rotor. this chart shows bearing deterioration damage is considerable, should repair entire unit-failure is imminent.

Vel Freq 96000 CPM	1/16/2004 9:24:19 AM	O/All 0.178 in/s rms	1800 RPM
Vel Freq 96000 CPM	9/22/2003 3:51:54 PM	O/All 0.105 in/s rms	1800 RPM
Vel Freq 150000 CPM	6/30/2003 8:17:31 AM	O/All 0.089 in/s rms	1800 RPM
Vel Freq 150000 CPM	6/23/2003 9:27:01 AM	O/All 0.102 in/s rms	1800 RPM
Vel Freq 96000 CPM	6/10/2003 2:43:12 PM	O/All 0.061 in/s rms	1800 RPM

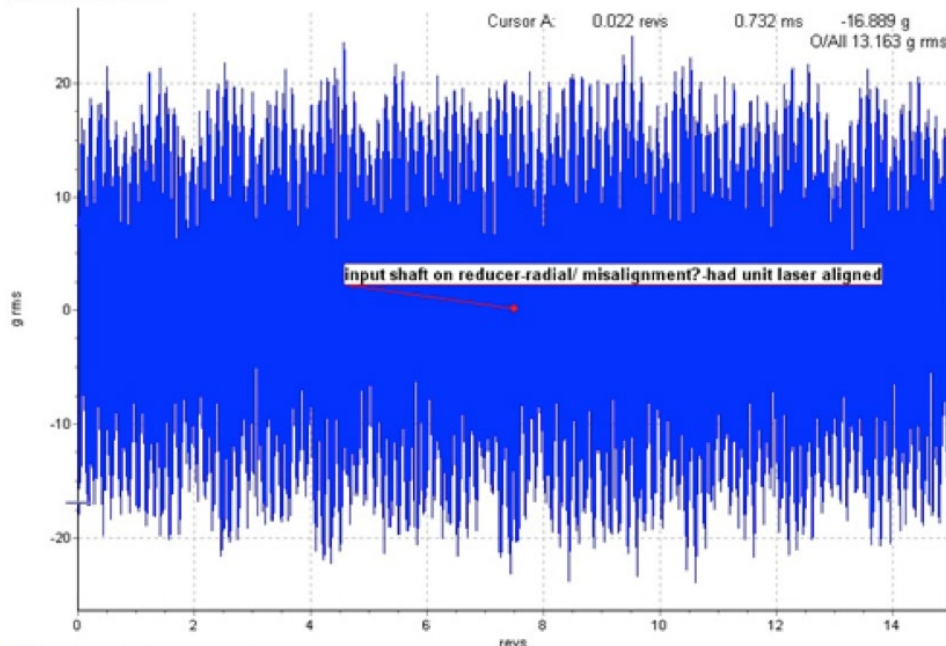
in-line drive - inputslant - Not specified - Acc Time 500 ms
6/23/2003 9:40:22 AM

6/23/2003 9:40:22 AM	O/All 13.163 g rms	1800 RPM
----------------------	--------------------	----------

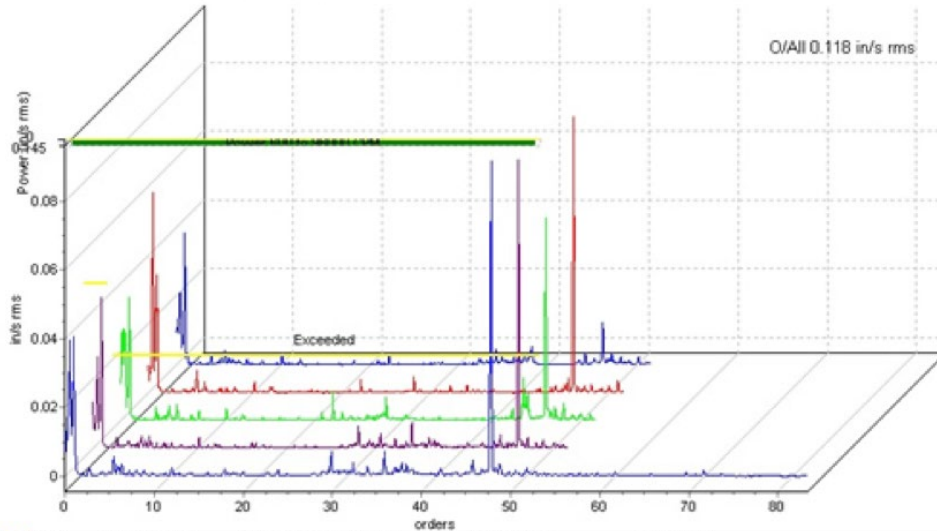
in-line drive - mtr-ode - Vertical

see motor de comments-damage is starting

Vel Freq 150000 CPM	1/16/2004 9:25:06 AM	O/All 0.118 in/s rms	1800 RPM
Vel Freq 96000 CPM	1/16/2004 9:25:02 AM	O/All 0.105 in/s rms	1800 RPM
Vel Freq 96000 CPM	9/22/2003 3:52:58 PM	O/All 0.098 in/s rms	1800 RPM
Vel Freq 96000 CPM	6/30/2003 8:18:32 AM	O/All 0.12 in/s rms	1800 RPM
Vel Freq 96000 CPM	6/10/2003 2:44:31 PM	O/All 0.059 in/s rms	1800 RPM

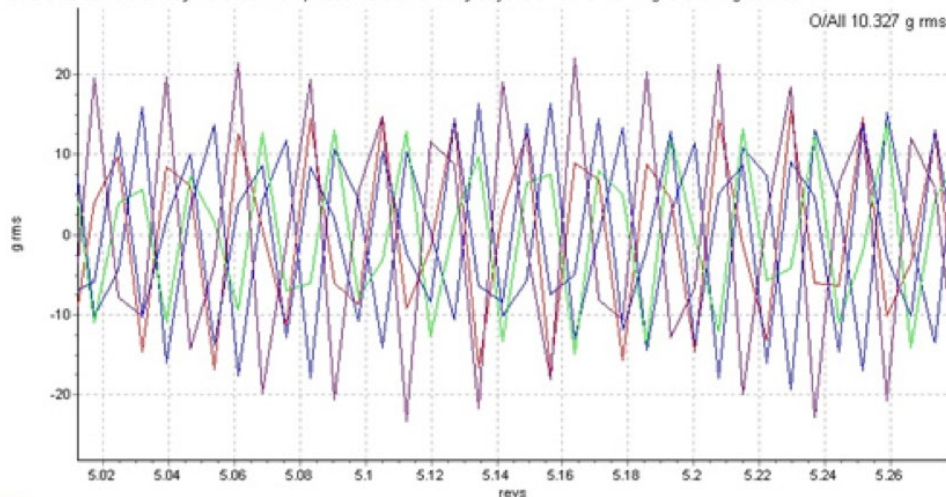
in-line drive - inputslant - Vertical - Acc Time 500 ms

4/1/03 is alarm of original warning.

6/10/03 is wear-in baseline 1/16/04 shows decrease-from wear-in-unit is headed for failure

6/10-9-22/03 note steady increase in amplitude-we are now way beyond a normal warning level of high concern.

1/16/2004 9:38:19 AM	O/All 10.327 g rms	1800 RPM
9/22/2003 4:02:55 PM	O/All 14.874 g rms	1800 RPM
7/11/2003 8:17:02 AM	O/All 8.189 g rms	1800 RPM
6/30/2003 8:22:32 AM	O/All 11.522 g rms	1800 RPM
6/23/2003 9:30:45 AM	O/All 11.161 g rms	1800 RPM

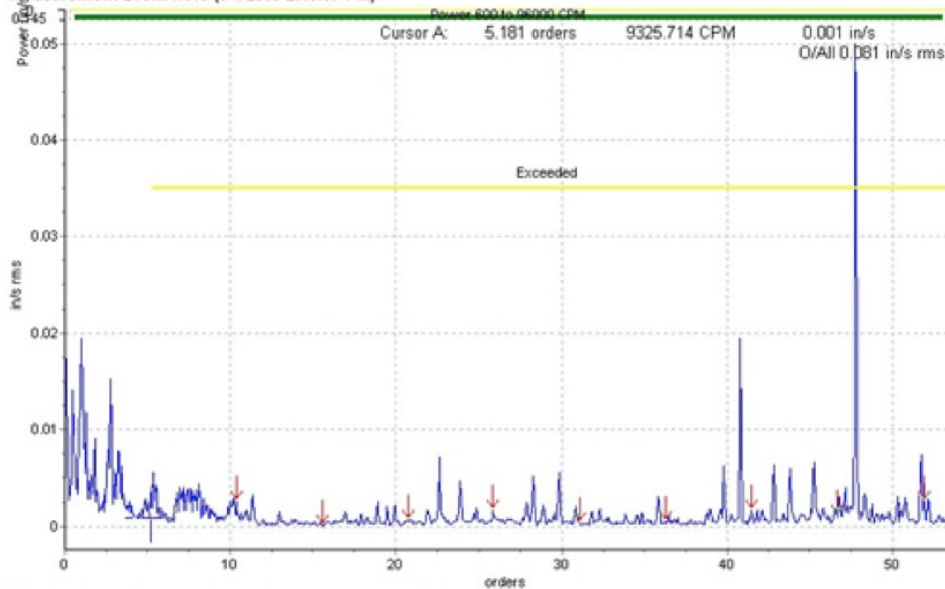
in-line drive - parallelshft<War - Vertical - Vel Freq 96000 CPM
4/1/2003 2:18:24 PM

same as inputslant and basis for my original warning-because it exists at all is of major concern to vibration specialists.
